Clutch Slave Cylinder & Linkage, Series II & IIA

Throw Out Bearing & Linkage, Series II, IIA

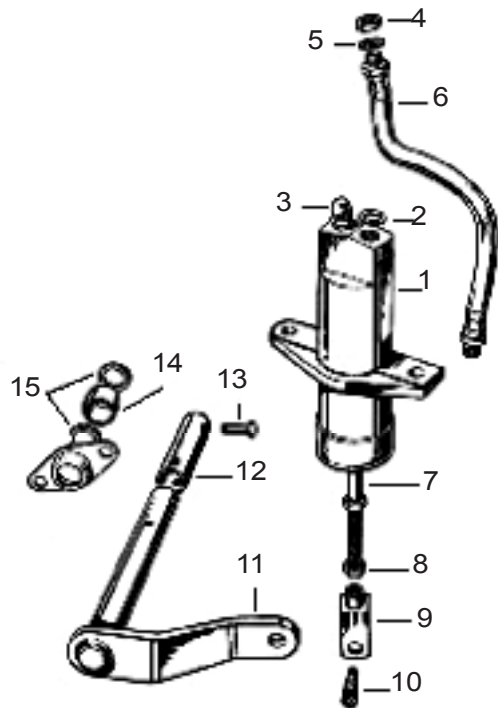
If the clutch on your Series II or IIA releases close to the floor, you know your clutch cylinders are in good condition and no amount of bleeding helps, chances are very good that your mechanical clutch linkage is worn out and needs replacing.

The mechanical clutch linkage is often one of the most neglected systems on a Land Rover because it just works. Over time and without periodic lubrication the pivot pins become grooved, the spherical bushing wears out, and the holes in the arms become oval. Added up this can translate to a lot of freeplay. The clutch should be released when the pedal is about half way to the floor.

The bronze bushing is porous and should be soaked in oil for 24 hours prior to installation. Be sure to oil the felt washers on either side of the bronze bushing as well.
